Clyde Terminal

Annual Environmental Performance Review

Reporting Period: 01 January to 31 December 2019

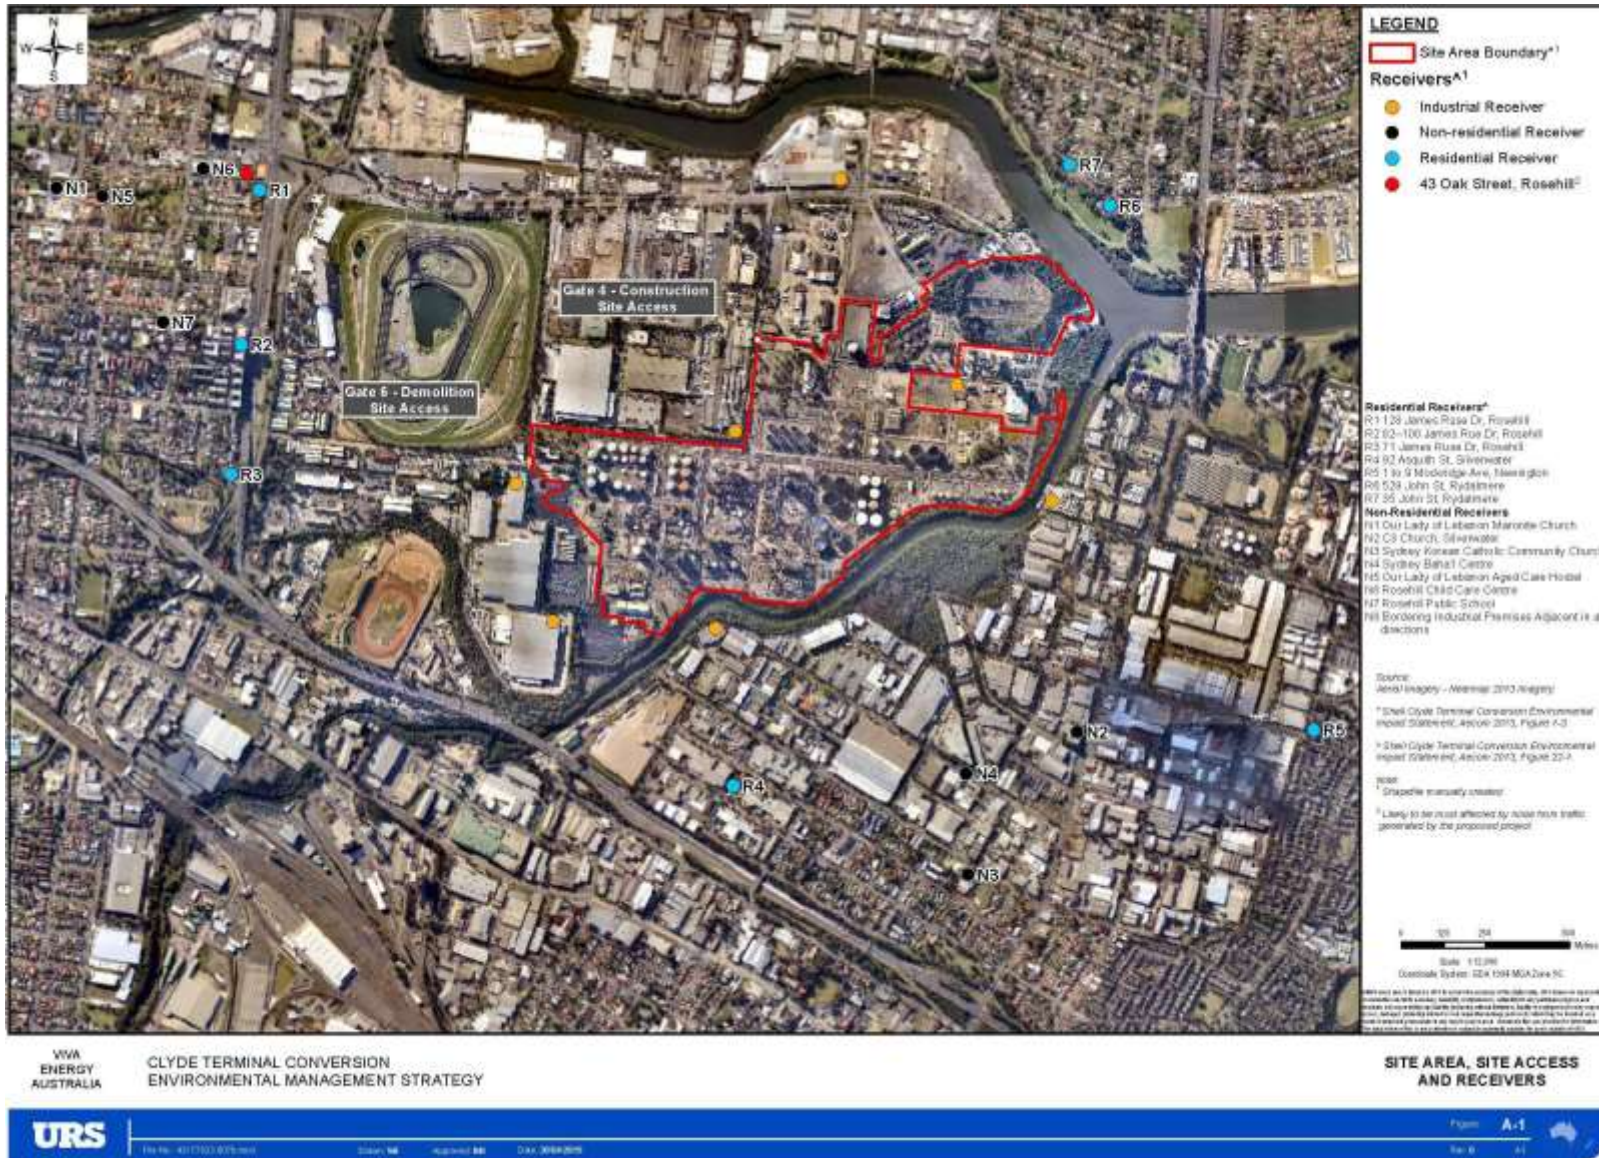
Figure 1 – Clyde Terminal site area, site access and receivers

On 14 January 2015, the Planning Assessment Commission of NSW (as delegate of the Minister for Planning) granted Development Consent (SSD 5147) for the project subject to a number of conditions. The Clyde Terminal currently receives finished petroleum products from the Gore Bay Terminal. These products are distributed by pipeline from the Clyde Terminal to the adjacent Parramatta Terminal road gantry and to Sydney Airport. The Clyde Terminal site area, site access and receivers are shown in Figure 1 below.

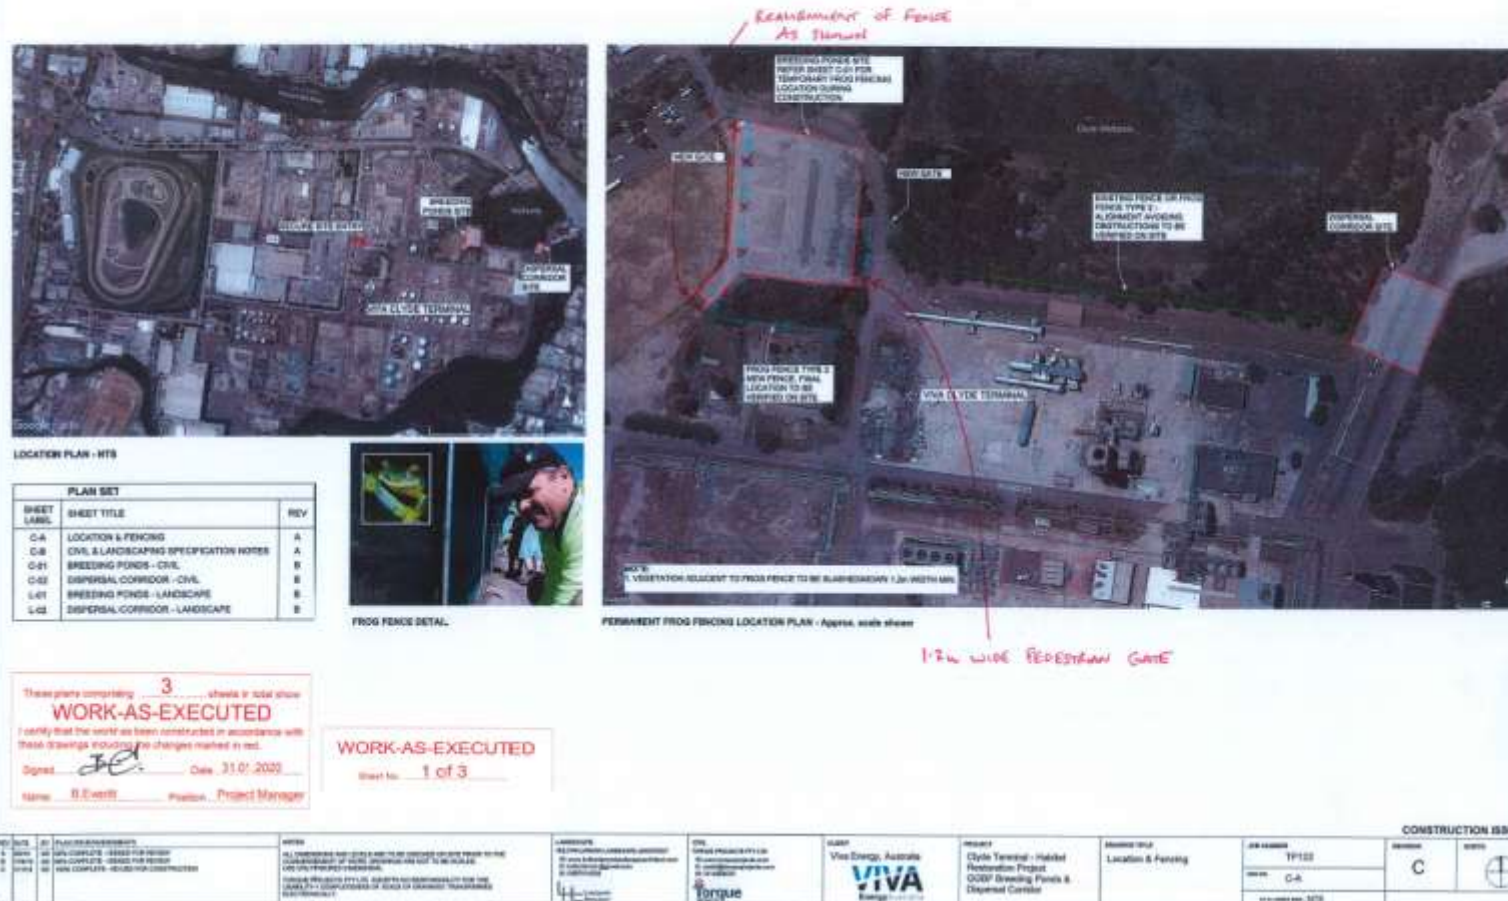
GREEN & GOLDEN BELL FROG BREEDING PONDS AND DISPERSAL CORRIDOR HABITAT RESTORATION PROJECT

Figure 3 – Green and Golden Bell Frog Habitat Restoration – Works as Executed

During the reporting period, the Green and Golden Bell Frog (GGBF) habitat restoration works were executed. These works included the construction of a Wetland mosaic adjacent to the Clyde main wetland to provide for improved breeding habitat conditions of the GGBF. Refer to Figure 3 for Works as Executed plan

In addition to the compliance status against each of the EPBC 2013/6878 conditions, the Annual Compliance Report also describes the progress on the Plans implementation. During the reporting period, the proposed wetland mosaic and dispersal corridor were constructed. Also, a frog-proof fence was installed along the wetland mosaic and main wetland to help contain the Green and Golden Bell Frog within their improved habitat and exclude them from construction and operational areas. Please refer to Figure 3 for the Works as Executed plan showing the frog fence detail.
