Clyde Terminal

Annual Environmental Performance Review

Reporting Period: 01 January to 31 December 2018

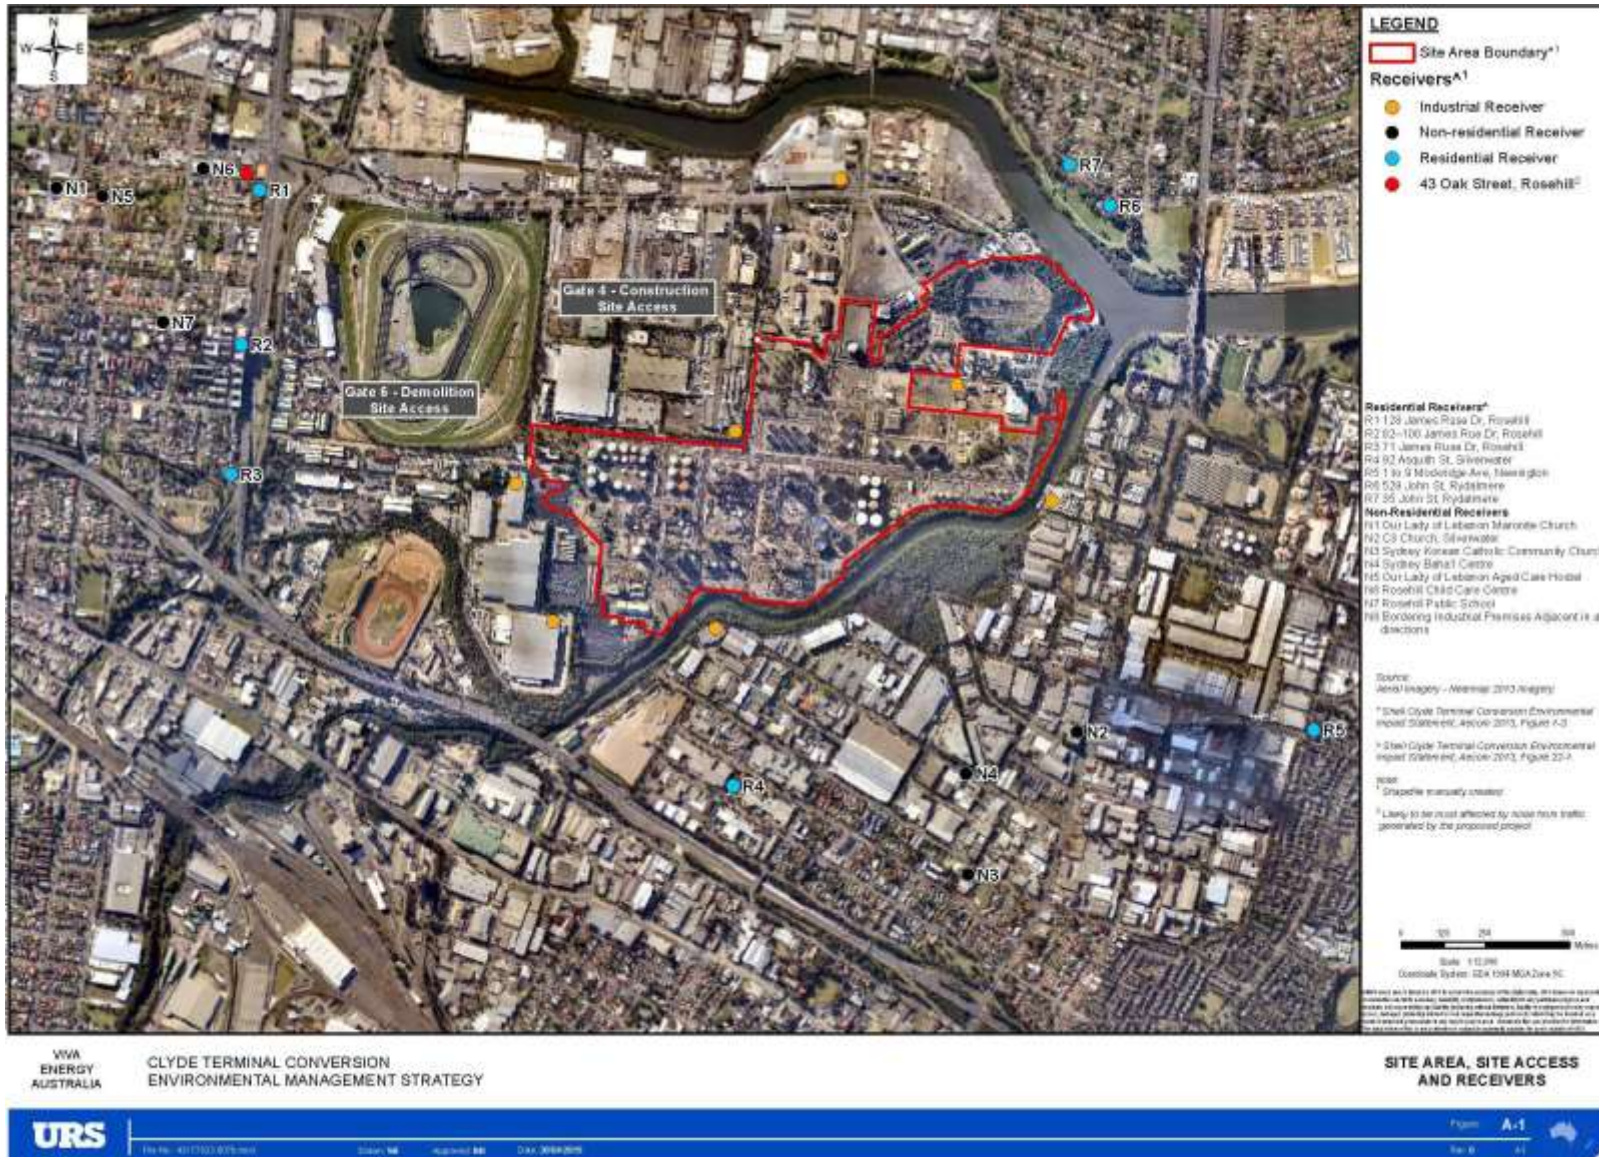
Figure 1 – Clyde Terminal site area, site access and receivers

On 14 January 2015, the Planning Assessment Commission of NSW (as delegate of the Minister for Planning) granted Development Consent (SSD 5147) for the project subject to a number of conditions. The Clyde Terminal currently receives finished petroleum products from the Gore Bay Terminal. These products are distributed by pipeline from the Clyde Terminal to the adjacent Parramatta Terminal road gantry and to Sydney Airport. The Clyde Terminal site area, site access and receivers are shown in Figure 1 below.

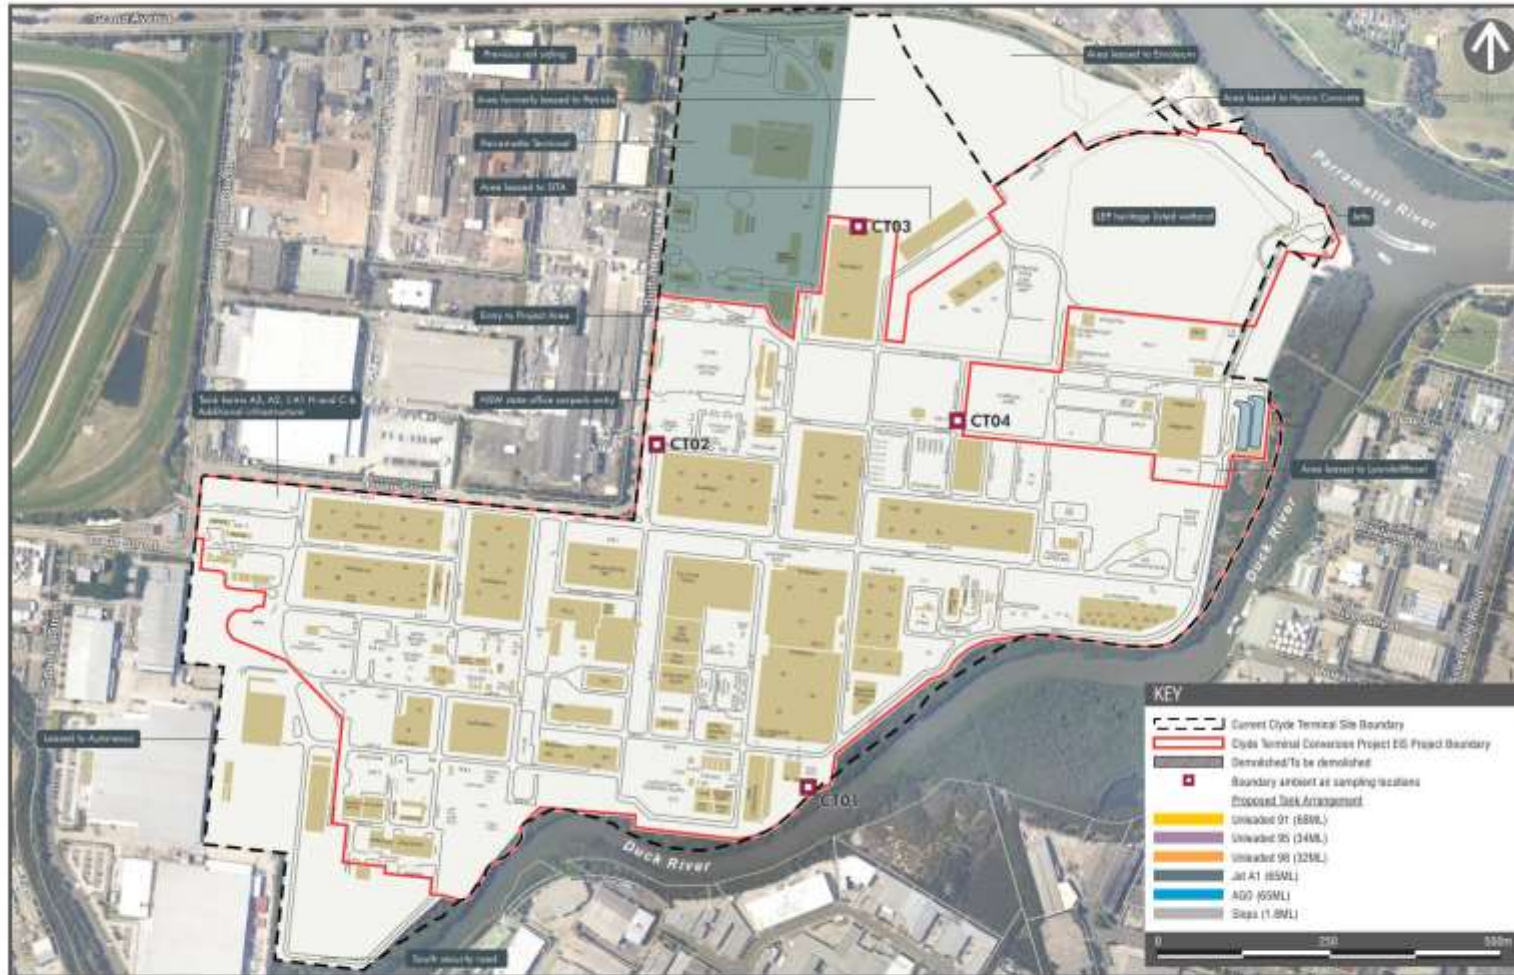
Figure 3: Boundary VOC sampling locations

The annual emission survey described in the above section also included VOCs sampling and analysis. Four boundary locations were surveyed based on likely peak impact areas identified in the EIS and variability in wind conditions, as depicted on Figure 4 below. Boundary ambient air sampling was conducted at each location using stainless steel evacuated canisters and flow controllers. Samples were collected over a period of over 20 hours and canisters were subsequently analysed for CoPC following method US EPA TO-15.

Monitoring results are summarised below in Table 3 with details presented on the Annual Air Quality Monitoring Survey report (Aecom, 2018). Minimum monitoring results for benzene and total VOCs are likely representative of background concentrations and correlate well with the EIS predictions. However, when considering the effect of background concentrations, average and maximum monitoring results for total VOCs and benzene appear to be under-estimated by the EIS model. This discrepancy may be explained based on adjacent off-site industrial activities and minor emission sources not included in the EIS model (e.g. waste water interceptors). Measured benzene values are within benzene concentrations likely to be experienced in Sydney's urban ambient air.

When comparing to the assessment criteria adopted in the EIS, all measured VOCs resulted in levels well below the applicable criteria
